Rail Accident Report

Detrainment of passengers onto electrically live track near Peckham Rye station 7 November 2017

Report 16/2018
October 2018

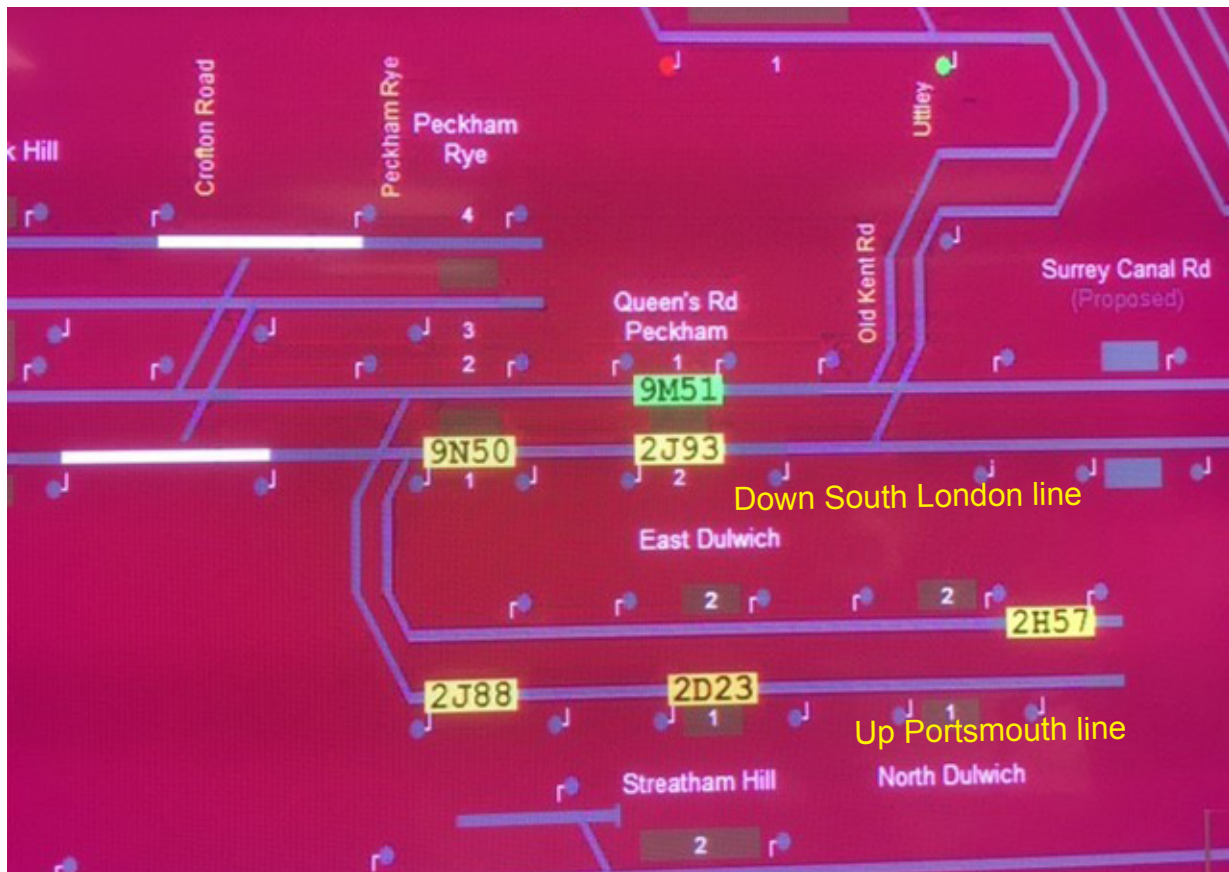
- 27 The IRC, having received brief details of the call from the TSC, checked the ARL train information management system on his control room monitor (figure 7) and observed that train 9N50 was shown on the screen as being at Peckham Rye station. The train was occupying the track circuit which includes the track in the platform at Peckham Rye, giving it the appearance of having reached the station. The IRC therefore assumed that the train was either fully or partially in the station platform. The IRC did not obtain any further details from the train driver, and immediately transferred the call to the Bombardier technician (ISST1) to work with the train driver to identify and rectify the train fault.

Figure 7: The ARL train information system screen

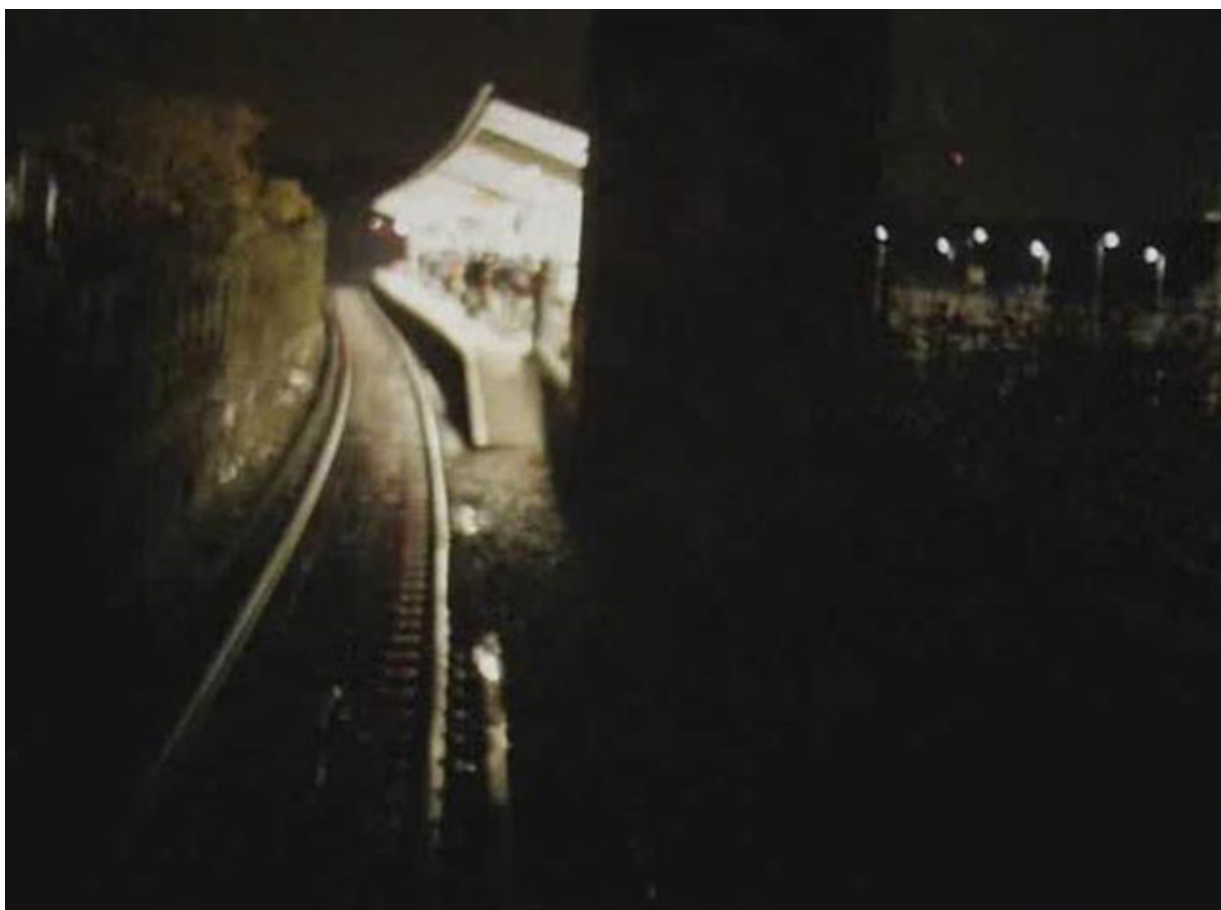
- 32 During this conversation, the train driver again advised ISST1 that he could not release the brakes and had no door interlock light⁷ illuminated. This information prompted ISST1 to request the train driver to '*recycle the doors*' on the train (ie to open and re-close the doors). The train driver questioned ISST1's advice, reporting that he could not do that as passengers were on board, and the train was not in the platform.

Figure 8: Image from train 9N50 forward facing camera (FFCCTV) showing the location of the train involved in the incident, and view towards Peckham Rye station

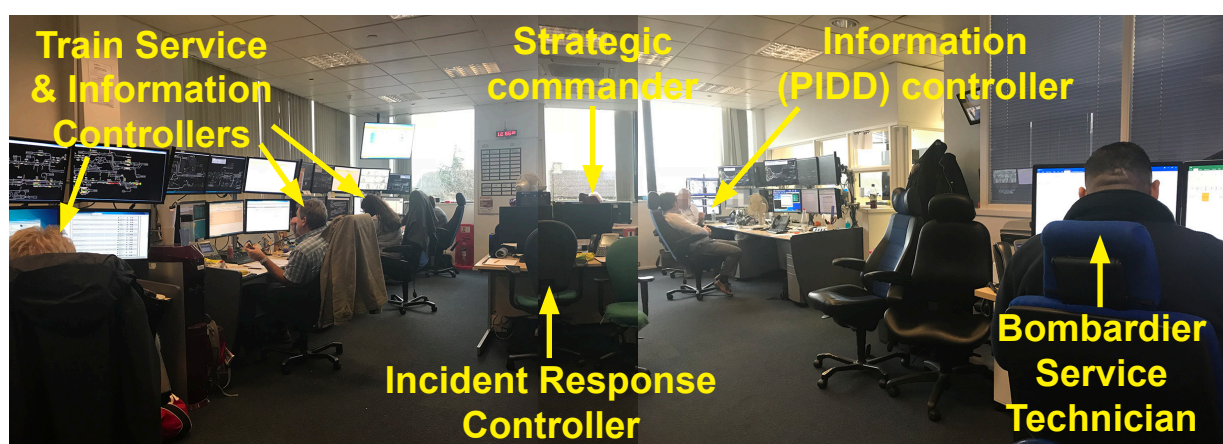
109 **ARL strategic command were not adequately prepared to manage the incident, which led to prolonged delays, a confused response to resolving the situation and a failure to understand that the events were developing into a dangerous incident.**

110 The restructuring of the ARL strategic command between April and October 2017 had led to changes in existing roles and the introduction of new roles. From May 2017, the strategic command development manager had started training staff. Witness evidence shows that the training was focused on individual training needs, rather than coordinated training through simulation or table top exercises with the object of equipping staff with the necessary skills to work as a team¹⁶, both in normal working and when coordinating incident response with external partners (Network Rail signalling staff and route control).

Figure 10: The position of the various roles within the ARL strategic command

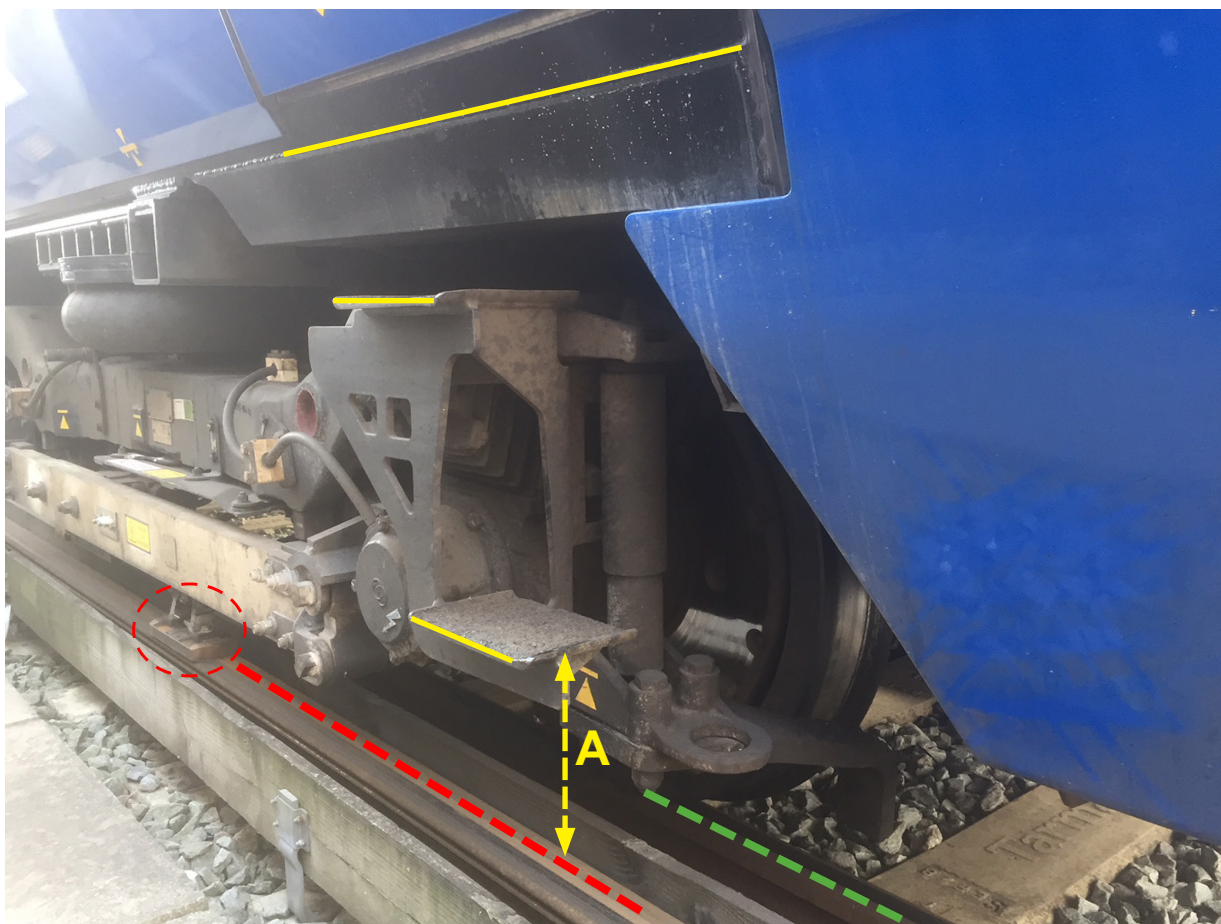
118 The detrainment on to the track side with passengers climbing down the steps and stepping over the live conductor rail and then walking on uneven underfoot conditions, in a dark and damp environment adjacent to the live rail, could have resulted in an injury or fatality. The desire of passengers to share information via social media was also potentially dangerous, as video evidence shows that at least one passenger, after leaving the train, was oblivious to the risk and crossed the live rail to obtain a better image.

Figure 11: Reconstruction showing the position of the steps from the train cab to the track side (yellow line), running rail (green line) and current collector shoe and energised live rail (red dotted line). The distance from the bottom step to the live conductor rail (A) is approximately 300 mm (image courtesy of Arriva Rail London). The wooden guard boarding shown in this photograph was not present at the location of the incident (see figure 12).

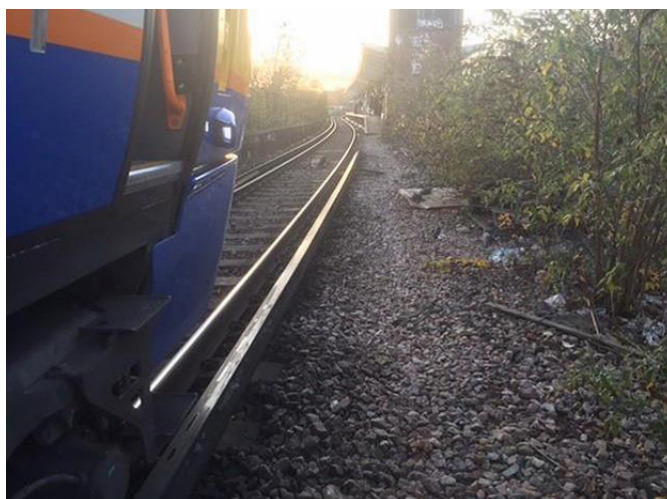
Figure 12: Reconstruction showing the position of train 9N50 relative to Peckham Rye station and the detrainment route (image courtesy of Arriva Rail London)
